Subject: **Inspection Report (4th of 6 Inspections) for Century Village (Durham B)**

Crowther Roof Check Maintenance Program-Inspection Report

Building Name: Century Village Durham B
Address: 3501 West Drive
City: Deerfield Beach, FL
Roof Type: Built-up Gravel Roof system

Work Order #: 7809

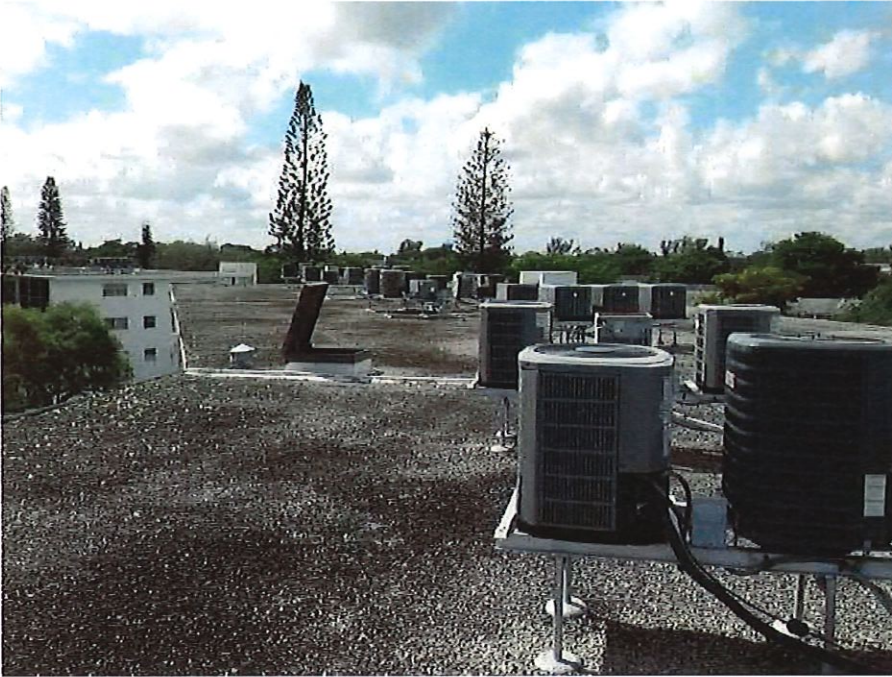
Appearance Overview

The appearance of the roof is in good condition at this time.

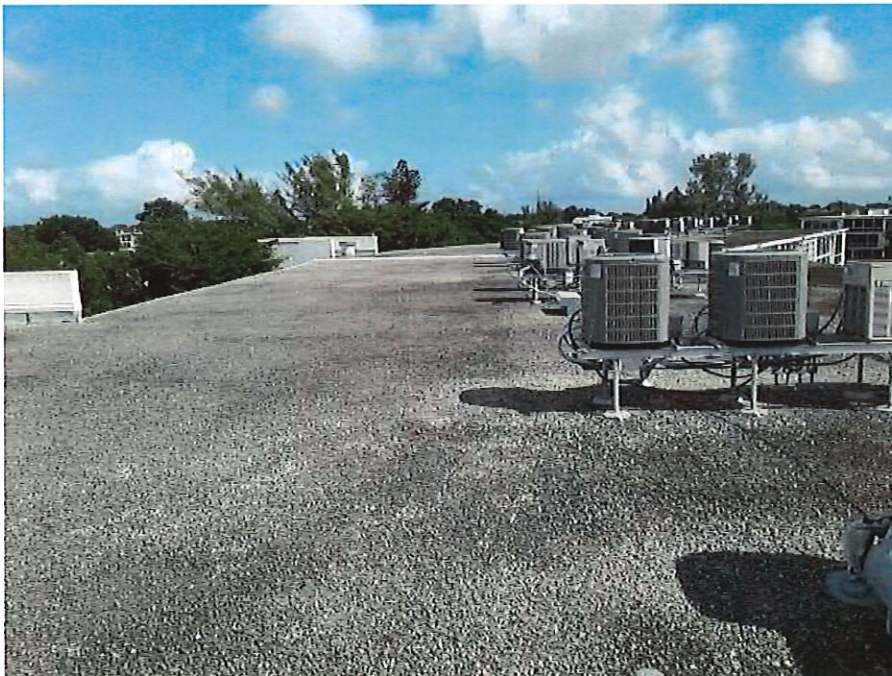
Appearance Overview

The appearance of the roof is in good condition at this time.

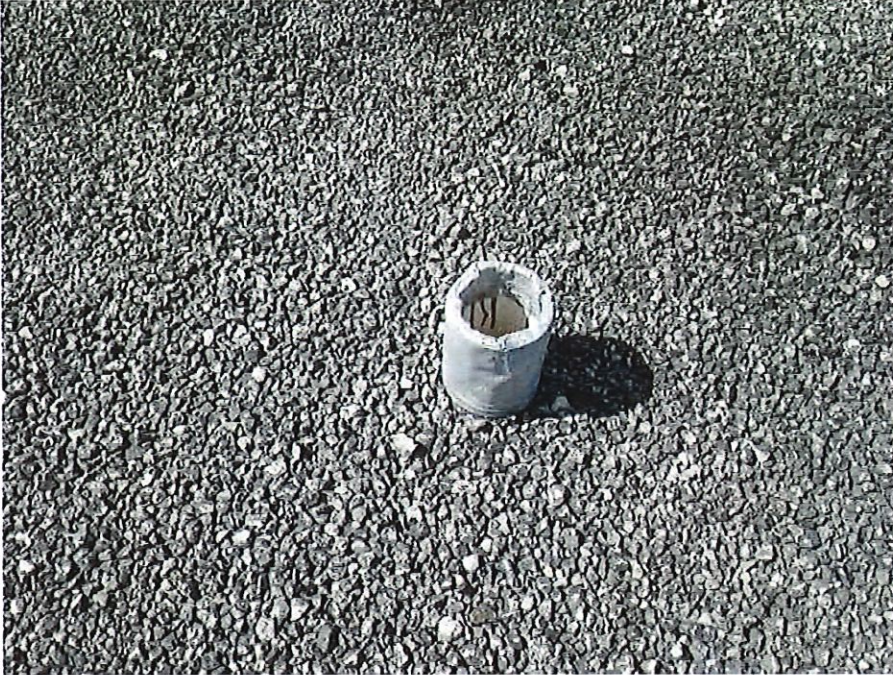
Lead Boots

Lead boots appear to be in fair condition at this time.

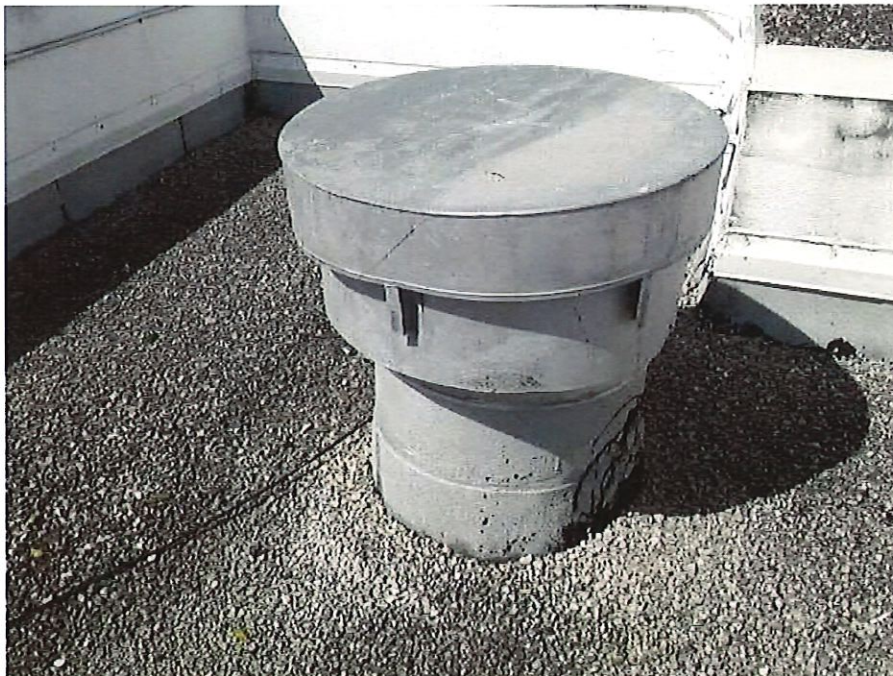
Roof Vents

Roof vents appear to be in fair condition at this time.

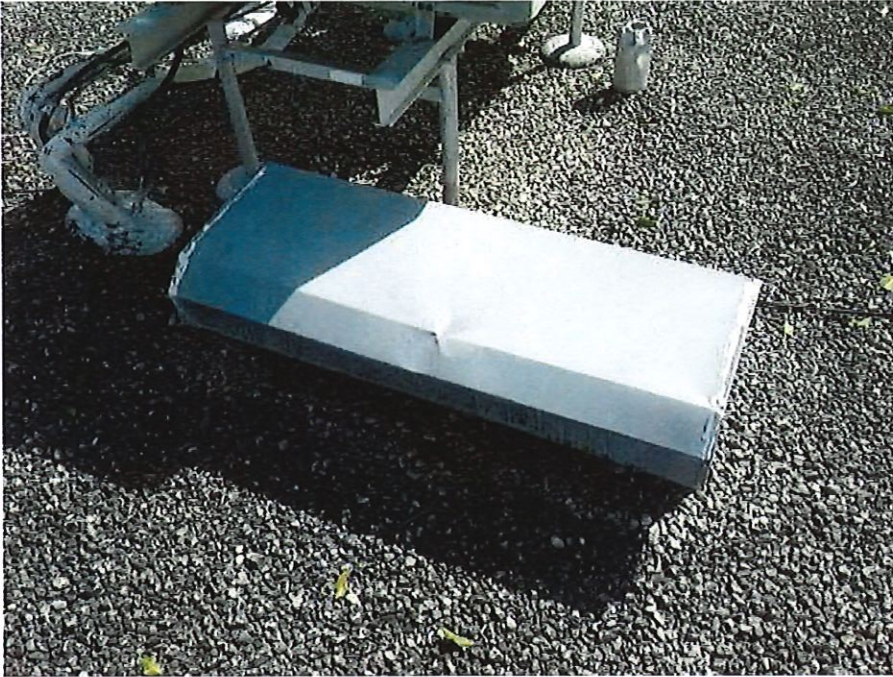
Roof Vents

Roof vents appear to be in fair condition at this time.

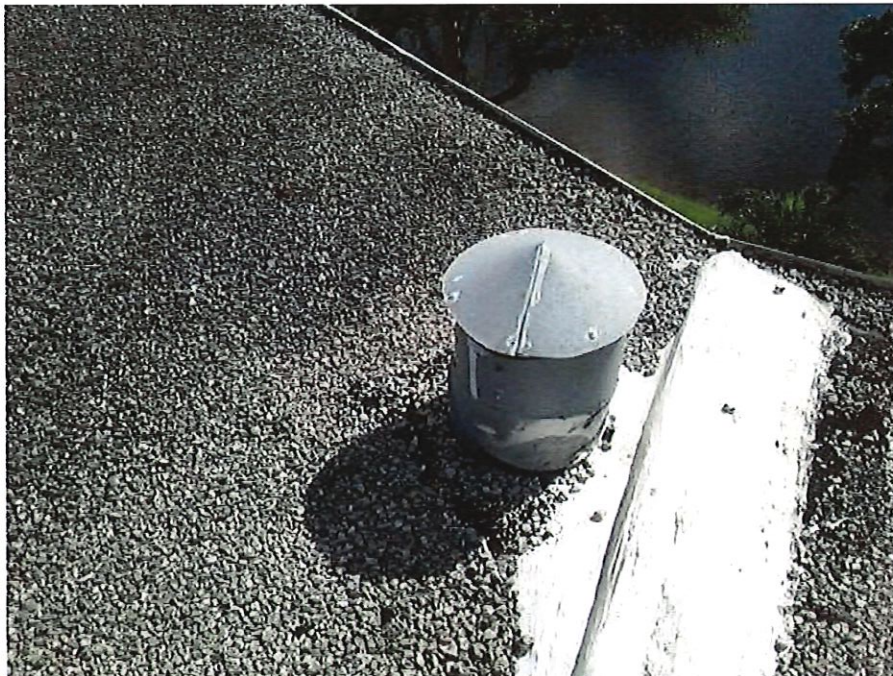
Roof Vents

Roof vents appear to be in fair condition at this time.

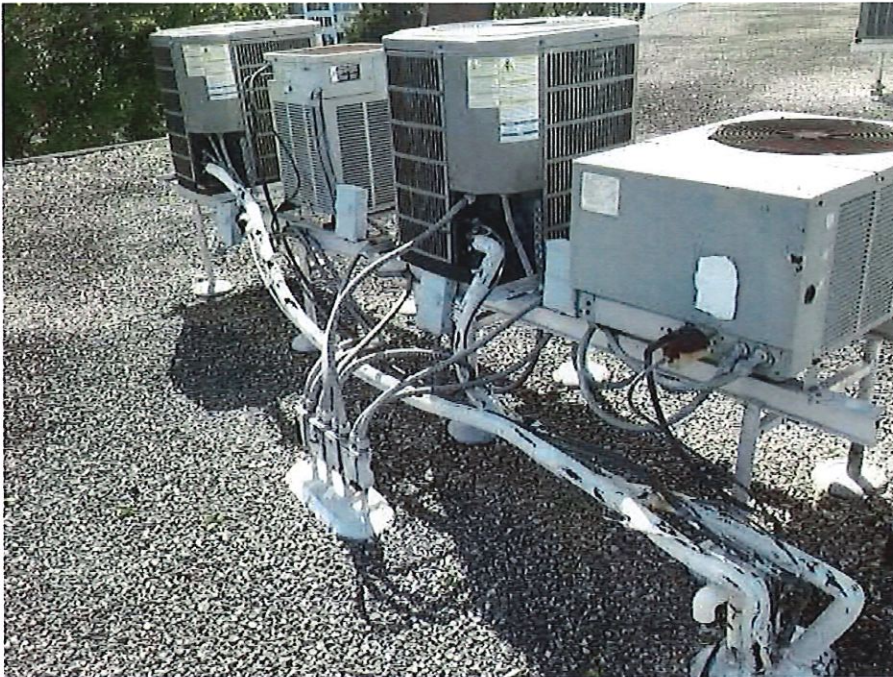
Equipment Housing

The equipment housing appears to be in fair condition at this time.

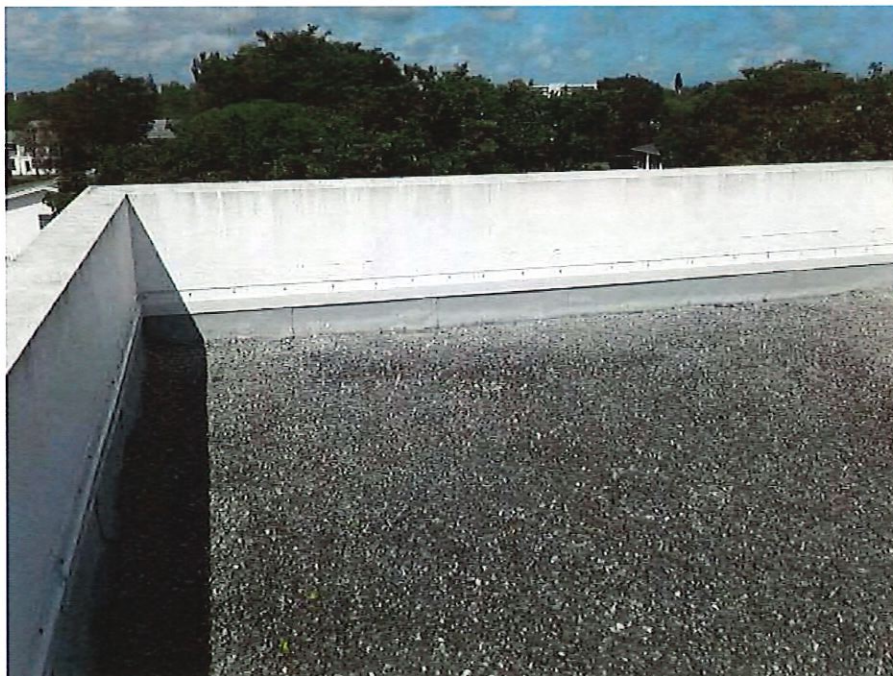
Wall

The walls appear to be in fair condition at this time.

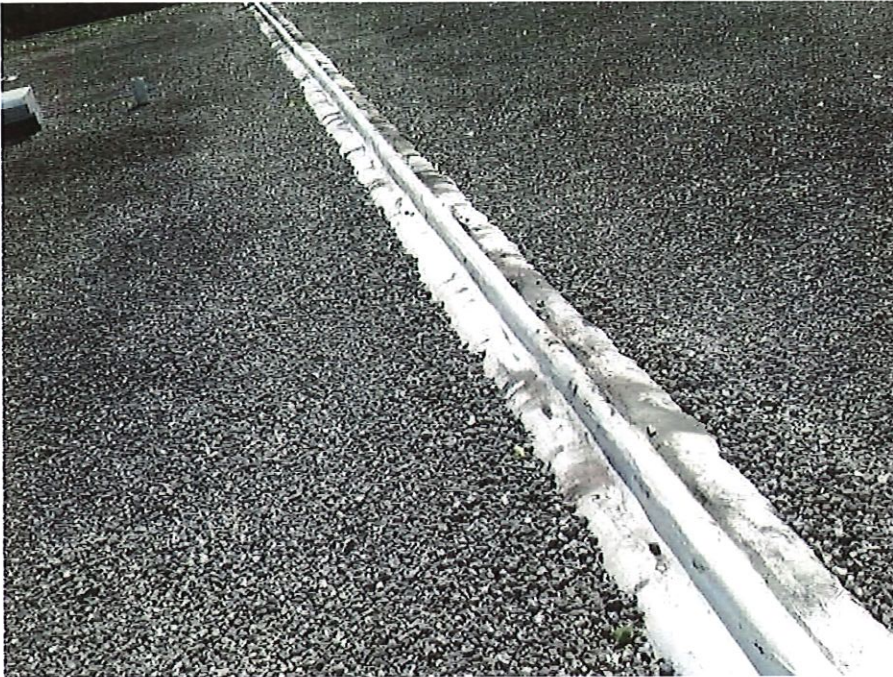
Expansion Joint

Expansion joint appears to be in fair condition at this time.

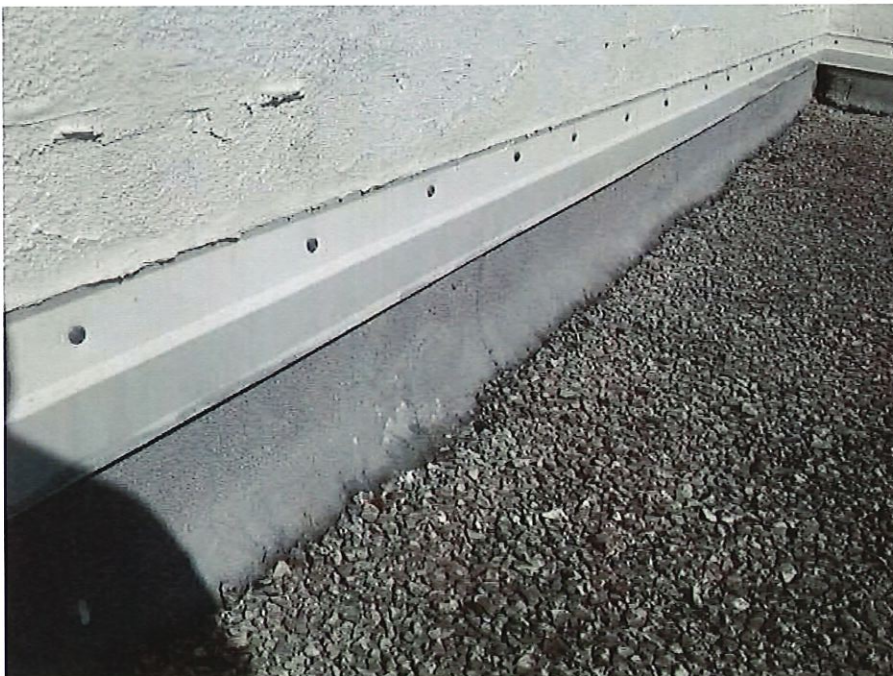
Counter Flashings

The counter flashing appears to be in good condition at this time.

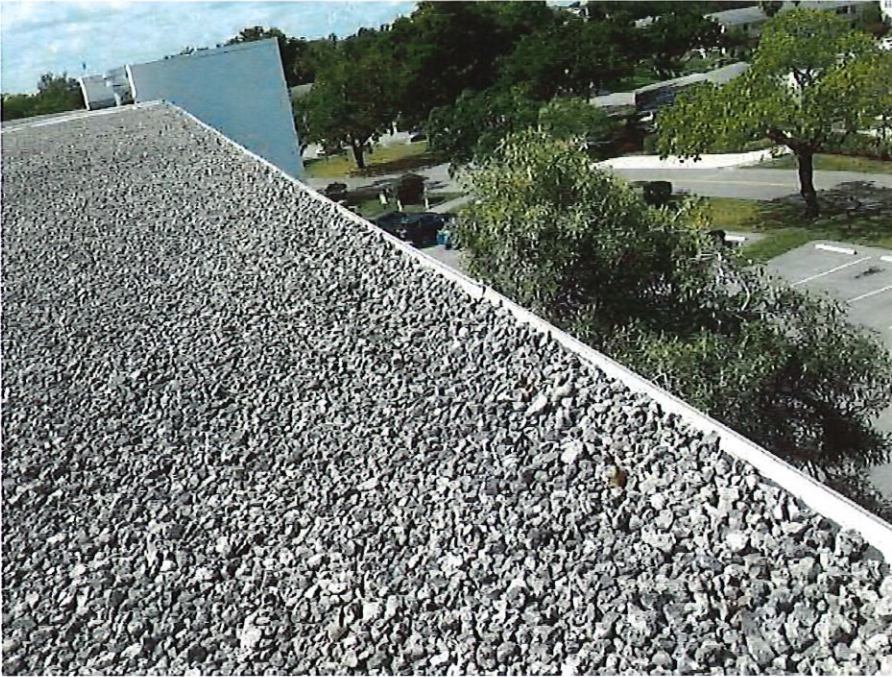
Gravel Stop

Gravel stop appears to be in fair condition at this time.

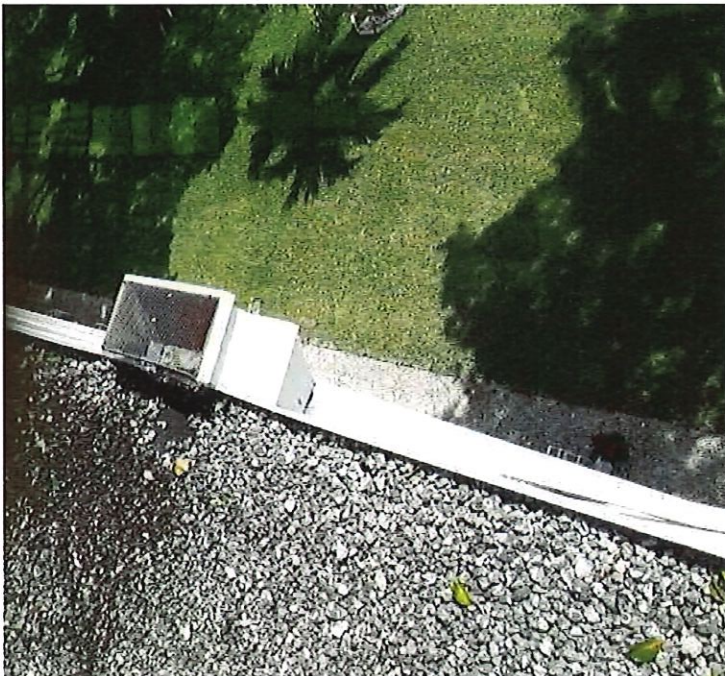
Downspouts

The downspouts appear to be in fair condition at this time.

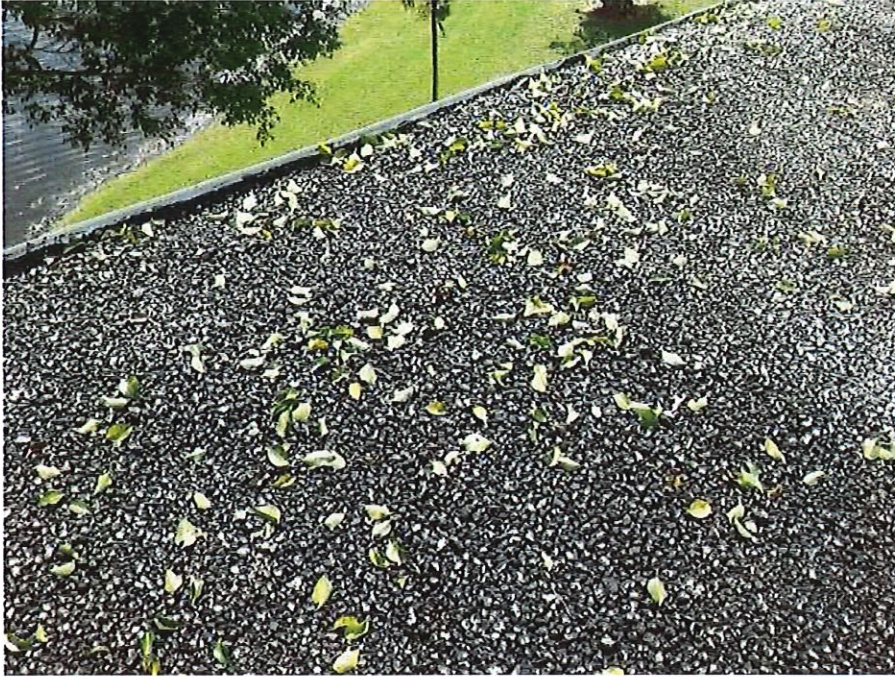
Debris on Roof

Identified debris on the surface of the roof that could damage or puncture the membrane.

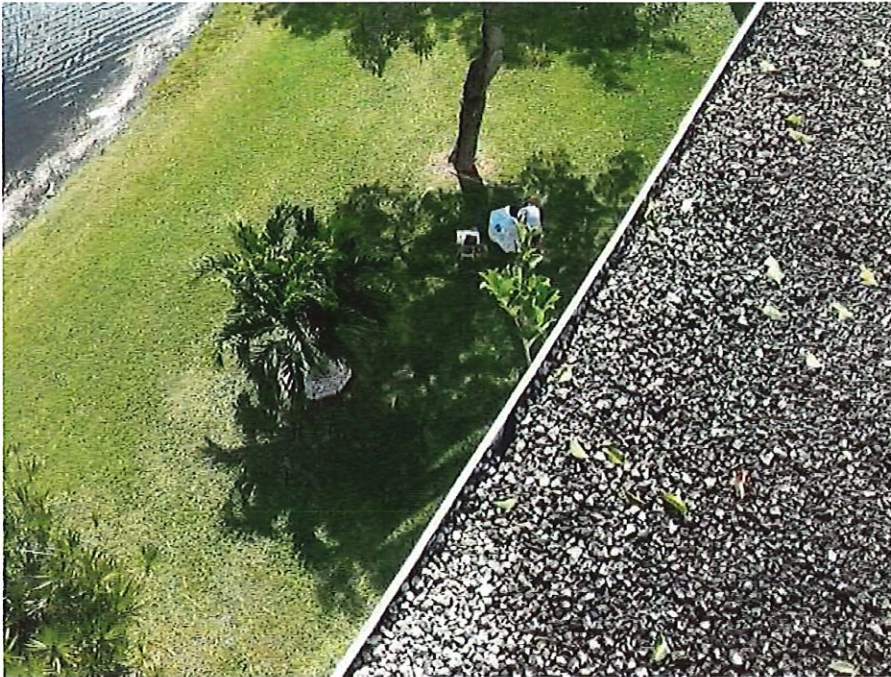
Debris on Roof

Identified debris on the surface of the roof that could damage or puncture the membrane.
